一、炼铁北 A#烧结机机头脱硫脱硝排口

二、能控北 2#排涝泵站

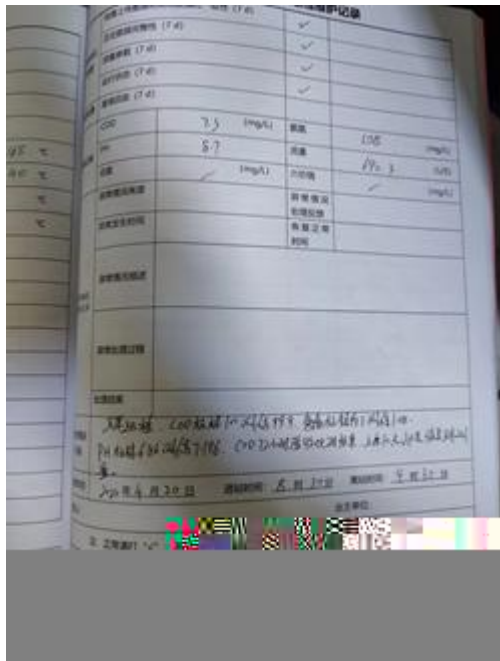
2022 4 18 -4 20 4#
 (CODcr) 18 76.10 mg/L 19 142.57
 mg/L 20 71.06 mg/L COD
 72 COD

*标记类型： 调试

*备注： 厂家调试

*监控点： 能控北4#排涝泵站

*子类型： 自动监测设备新装调试
